Model: Met-MF3	Date: 2-Oct-19	No.: RD0BL026a
----------------	----------------	----------------

Subject: How to overwrite temporary firmware		Prepared by: Yuusuke Taniguchi	
From: 2nd Tech Support Sec. Service Support Dept.			
Classification:	<input checked="" type="checkbox"/> Troubleshooting	<input type="checkbox"/> Part information	<input type="checkbox"/> Action required
	<input type="checkbox"/> Mechanical	<input type="checkbox"/> Electrical	<input checked="" type="checkbox"/> Service manual revision
	<input type="checkbox"/> Paper path	<input type="checkbox"/> Transmit/receive	<input type="checkbox"/> Retrofit information
	<input type="checkbox"/> Product Safety	<input checked="" type="checkbox"/> Other (Firmware)	<input type="checkbox"/> Tier 2

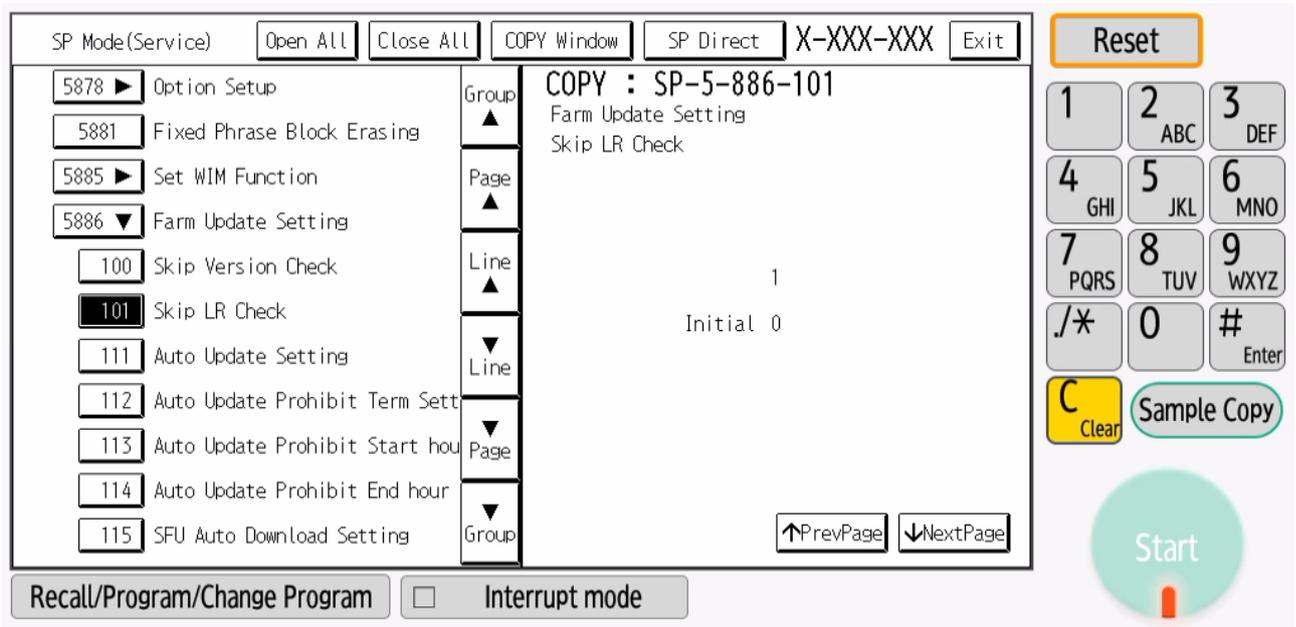
1. Enter the SP mode and change SP5-886-101 (Farm Update Setting: Skip LR Check) to “1”, and then tap the “#” key on the operation panel.
