# RTB No.: RD0BL026a : How to overwrite temporary/customized firmware

Published 10/04/2019 03:24 AM | Updated 12/25/2019 02:35 AM | Answer ID 265403

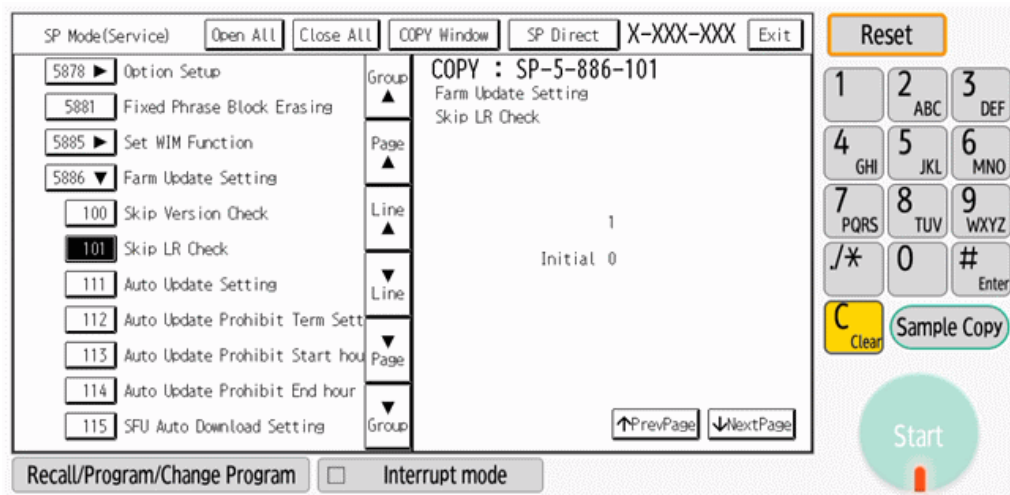
1. Enter the SP mode and change SP5-886-101 (Farm Update Setting: Skip LR Check) to "1", and then tap the "#" key on the operation panel.
